Manhole Inspection Summary

Manhole # S31E__020MH

Insp Date: **12/16/08 10:27 AM**

Location Address: **128 W Lexington St**

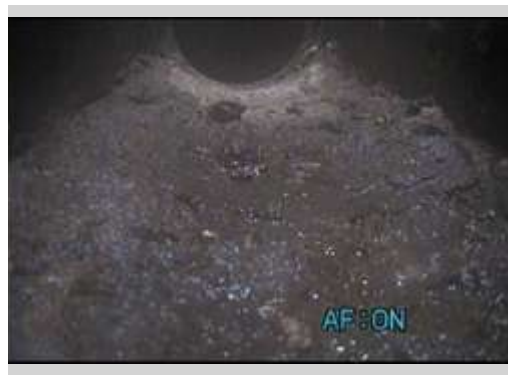
Condition: ☐ Sound ☐ Cracked ☐ Root Intrusion ☐ Deteriorated ☐ Leaks ☒ **Debris**

channel debris

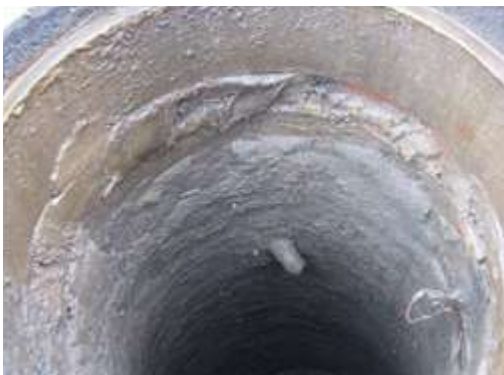
Defect 6

Frame Offset: **0** (in.) Condition: ☐ Sound ☐ Cracked ☒ **Leaks**

Infiltration: ☐ None ☒ **Joint** ☐ Cracks ☐ Mortar ☐ Roots ☐ Wall

lid/frame and chimney infiltration

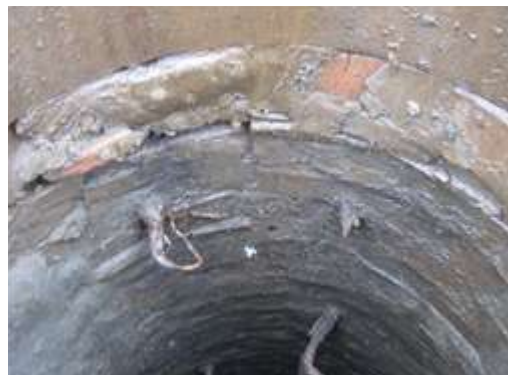
Defect 5

Condition: ☐ Sound ☐ Cracked ☐ Root Intrusion ☒ **Loose Brick** ☒ **Deteriorated**

missing mortar at frame, chimney loose bricks, deteriorated

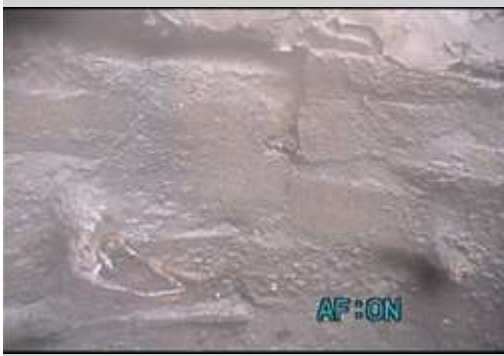
Defect 3

Steps Count: **7** Missing: **1** ☒ **Corroded**

broken corroded missing rung

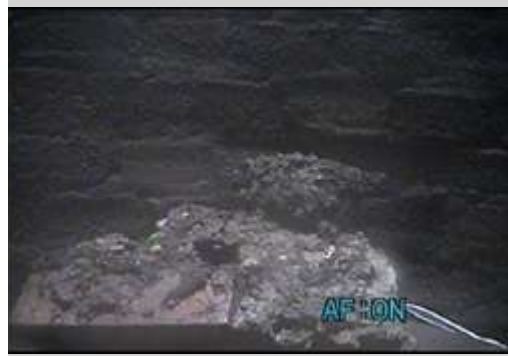
Defect 2

debris on bench
